Woodworking machinery at its best!

Symptom: The DC50AUTO Extractor runs correctly in manual mode, but behaves erratically or will not start in Auto mode:

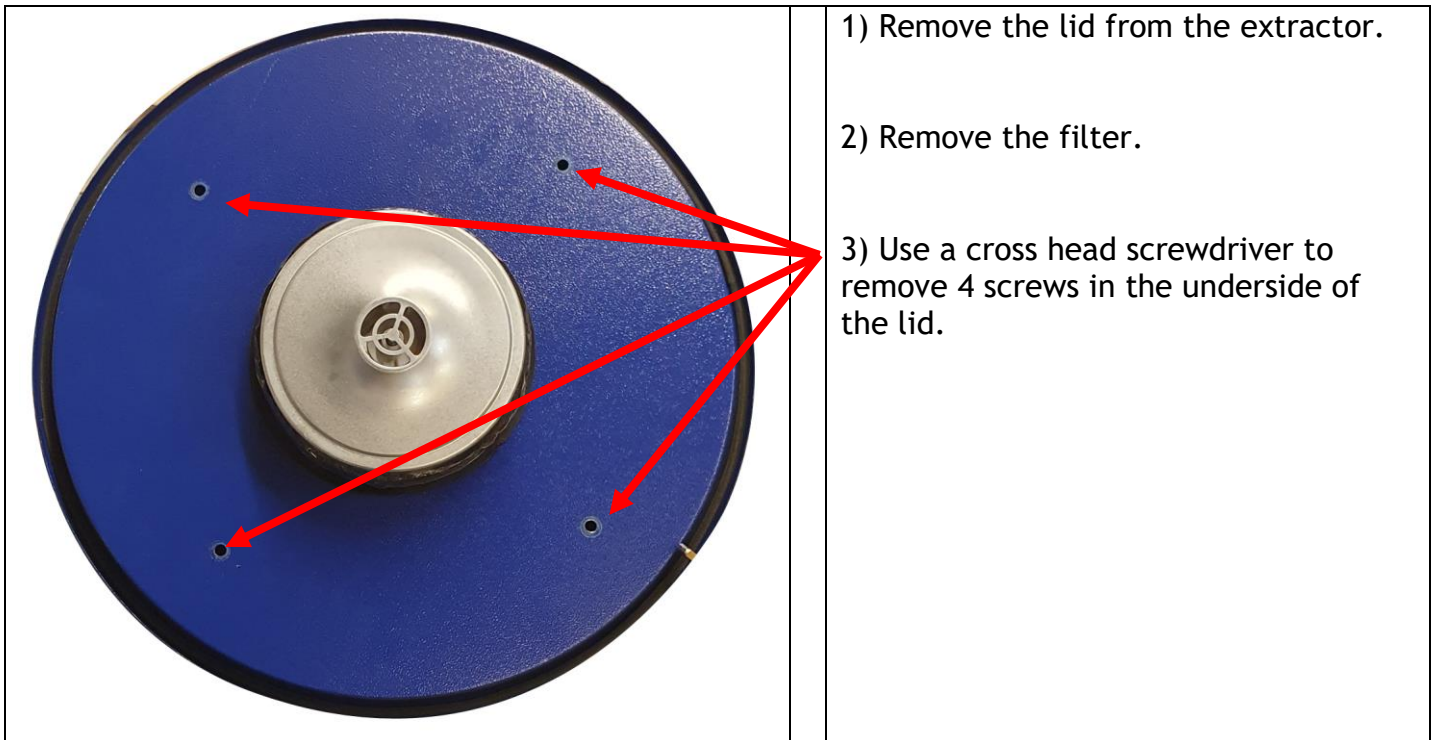
Cause: Failed relay on the PCB

Solution: The PCB needs to be replaced.
