LAGUNA 16|32DS Drum Sander Issue

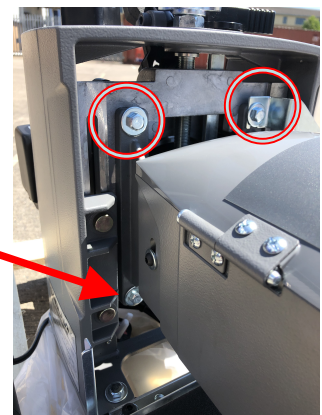
Picture 1

- 1) Source two pieces of timber approx 2" high
- 2) Raise sander drum to its maximum height.
- 3) With a 12mm socket unscrew and remove the two lower bolts that hold the drum to the main body. (lower left hand bolt shown with the arrow)
- 4) Bring the drum sander head back down to rest on the two pieces of timber. Then undo the two top bolts holding the drum to the main body – these are circled in picture 1. Also raise the height scale held on the top right bolt and tape it up out of the way.
- 5) Now pull the drum sander head away from the motor and rest it on the timber. The couplings will disengage. Keep the rubber 'spider' safe.
- 6) Remove both couplings using an allen key to undo the two grub screws found on each coupling that secures it to the shaft. You may need to gently pry them off using a lever as they can be tightly fitted. Keep the drift keys safe that fit into the shafts.

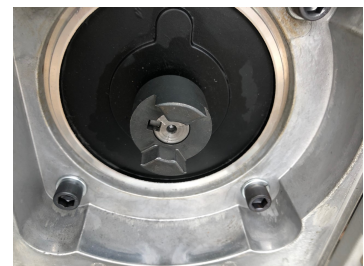
Picture 3 : The refitted motor coupling sitting flush to end of shaft with the drift key in place.

- 7) Refit the new motor coupling first. Re-install the drift key and push the coupling onto the shaft so that the end of the shaft sits flush with the coupling interior. See pic 3. Then re-tighten both grub screws. (Note; you do not need to loosen or back off the grub screws on the new couplings before fitting to the shaft)

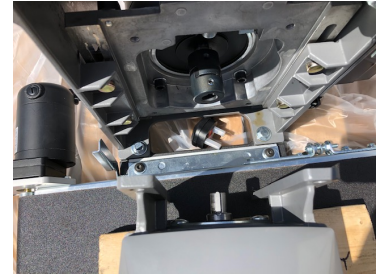
Picture 4 : Drum shaft before re-inserting into drum coupling.

9) Ensure the drift key is fitted to the drum shaft, and keeping the drum on the timbers to ensure the right height, line up drift key slots and push the drum shaft into the rear of the second coupling. See pic 4

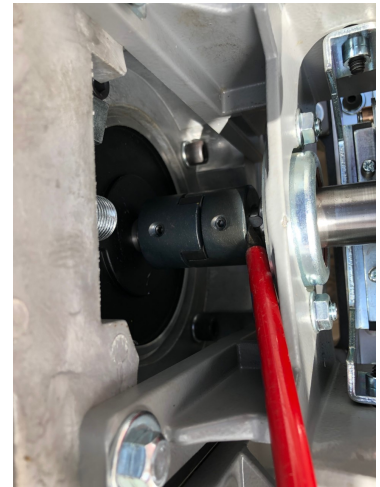
Picture 5 : Add a bit of leverage to push the couplings together before tightening up the two grub screws on the drum coupling.

11) This will have now pulled the drum shaft tighter into the coupling and the drum coupling can now be re-tightened using the two grub screws. See pic 5 as to how to apply some pressure on the coupling assembly before tightening to ensure a tight fit.
